FMS
Mater Dei Hospital | Malta
Volume 2: MAU building

Issue | 20 May 2015

MAU building executive summary

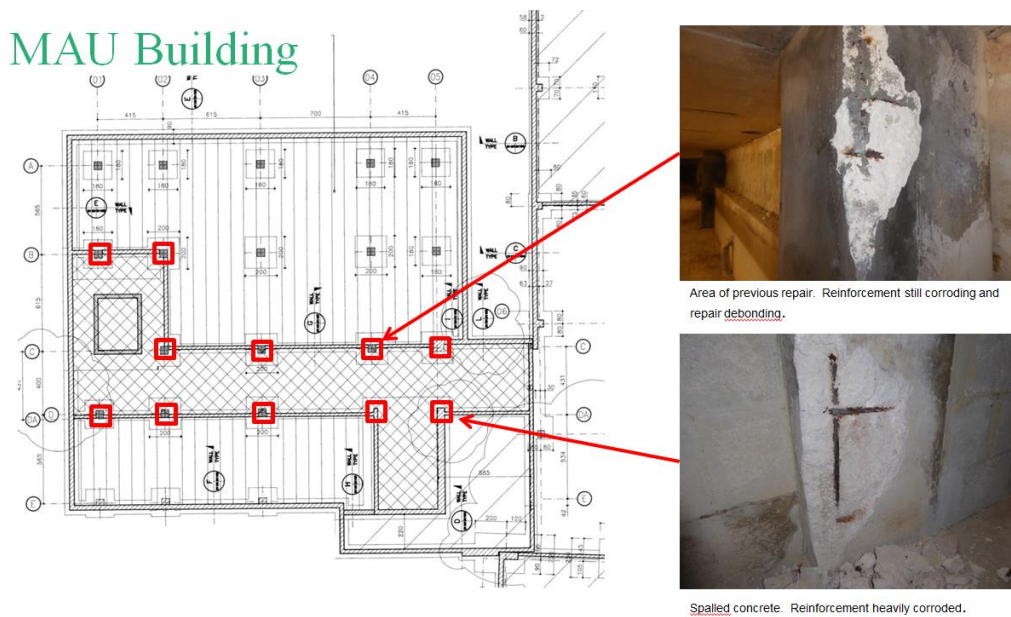
In the service tunnel to block D1.1 evidence of previous concrete repairs was found. Those repairs had not been effective in stopping corrosion of the reinforcement. As a result, corrosion of the reinforcement had continued, leading to spalling of the repair mortar and a progressive reduction of column capacity.

Figure 4 Areas of corroded reinforcement

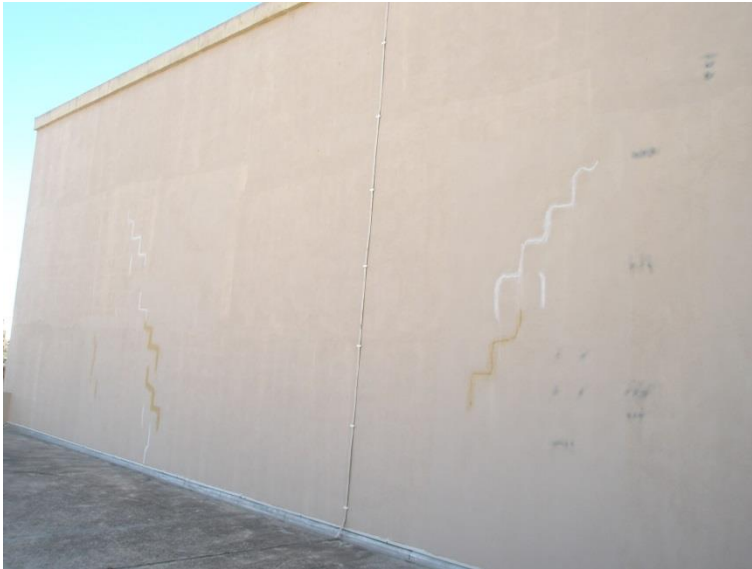
Figure 5 cracking in brickwork around plant room D1.3

Minor cracking was observed to some external masonry walls, particularly to plant rooms at roof level. The cracks are in keeping with movement-related cracking (i.e. frame deflections and thermal movements) and we do not believe that they are a structural concern for the wall.

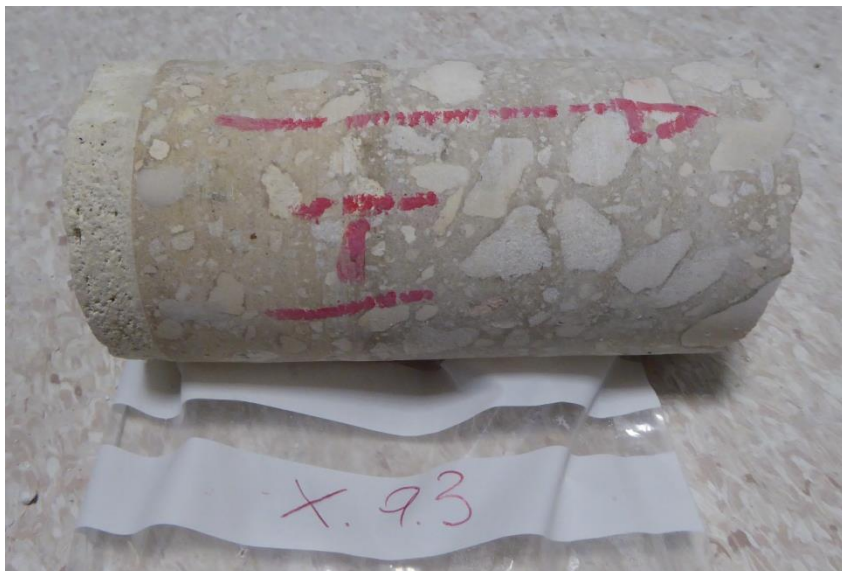
The Arup/ CRL tests in October 2014 similarly showed that in a significant number of test locations the carbonation depth was well advanced and had reached the depth of the steel reinforcement.

Figure 6 Concrete core from level 9 from MAU showing change in colour

This level of carbonation is considered high for good quality concrete of this age. Typically for concrete 20 years old carbonation would be expected to be less than 20mm.

The consequence of the advanced carbonation is the increased risk of corrosion to the reinforcement in the concrete elements. This is particularly important in the Level 8 areas and Level 11 plant rooms where the columns are in high humidity environments. In level 9 and 10 the columns are typically plastered and are within the climate controlled conditions of the hospital wards and operating theatres, here the humidity is unlikely to reach levels high enough to initiate significant corrosion.

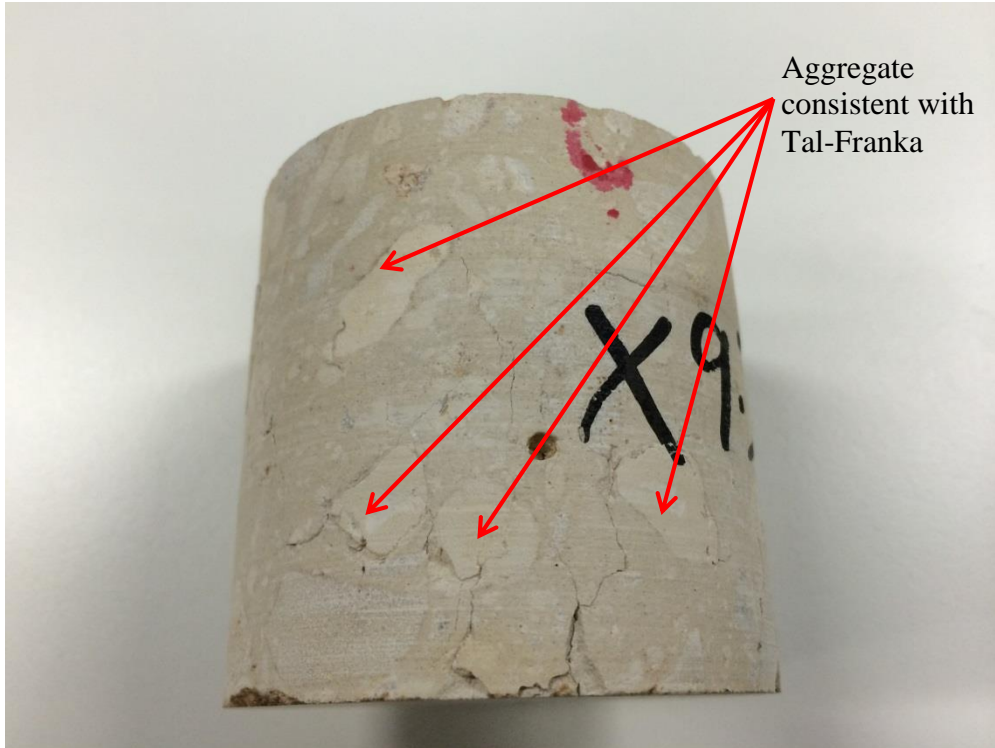
It is understood that concrete in Malta should contain only Tal-Qawwi aggregates. Visual inspection of the cores identified some inclusion of Tal-Franka. The figure below highlights the aggregate consistent with Tal-Franka.

This may contribute to the low strength observed in the cores. The construction documentation includes mix designs and cube tests from 1996-2000. It is not known if the cubes tested included Tal-Franka aggregate, however if it is believed that the cubes were made of the same concrete supplied to the columns then the cube crushing results would reflect a mix containing Tal-Franka.

Figure 7 Core showing aggregate consistent with Tal-Franka

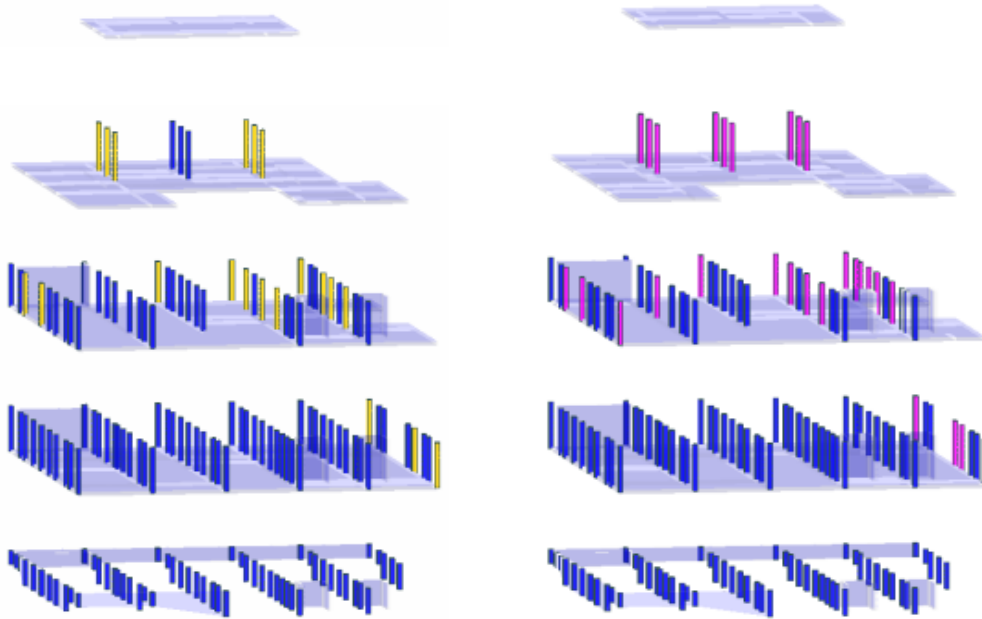
Figure 9 shows an example for block D1.3 with yellow and pink columns representing over stressed in the strength condition under different assessment criteria.

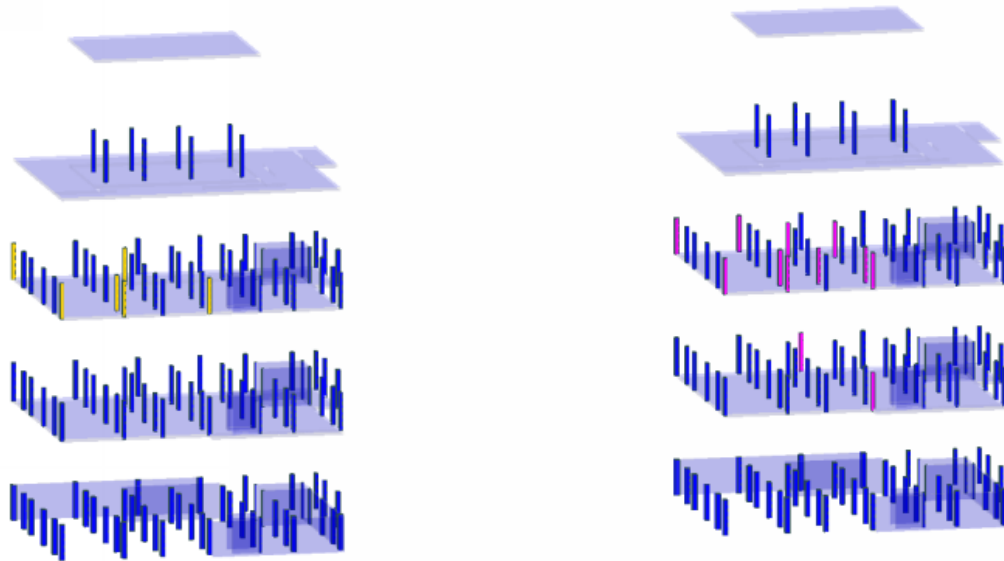
Figure 10 an example of the columns over rotated under significant damage limit state for one seismic load case.

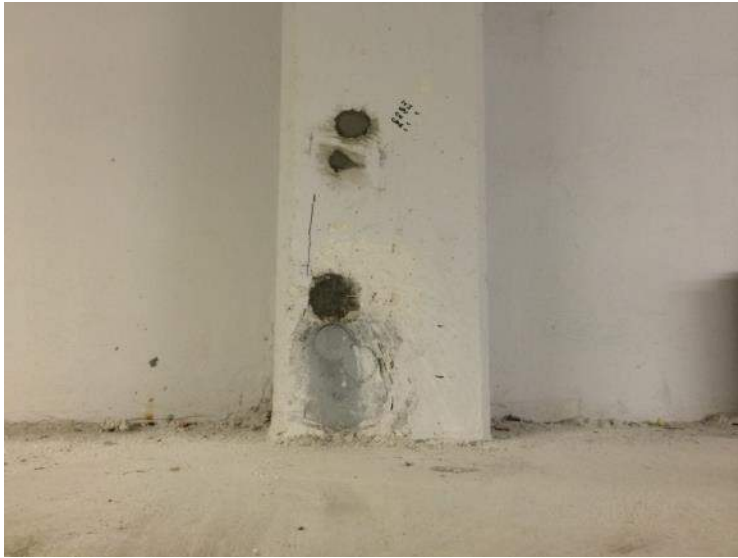
Figure 1: Multiple cores in single column

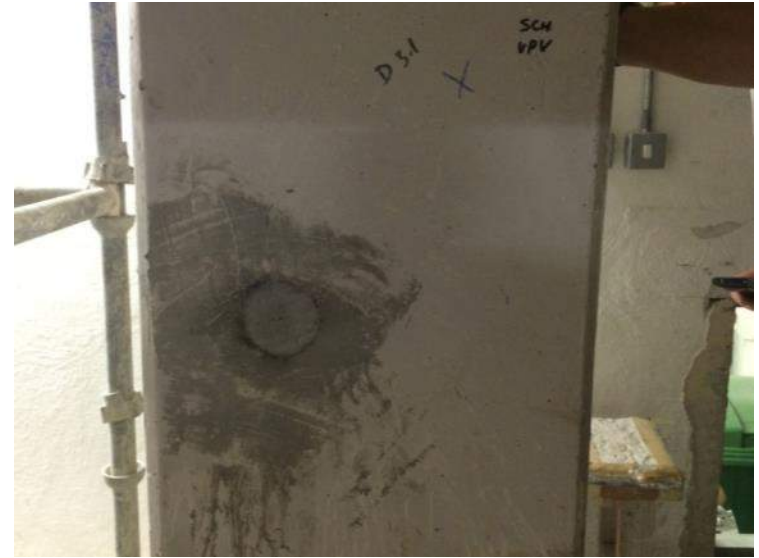
Figure 2: Repaired core

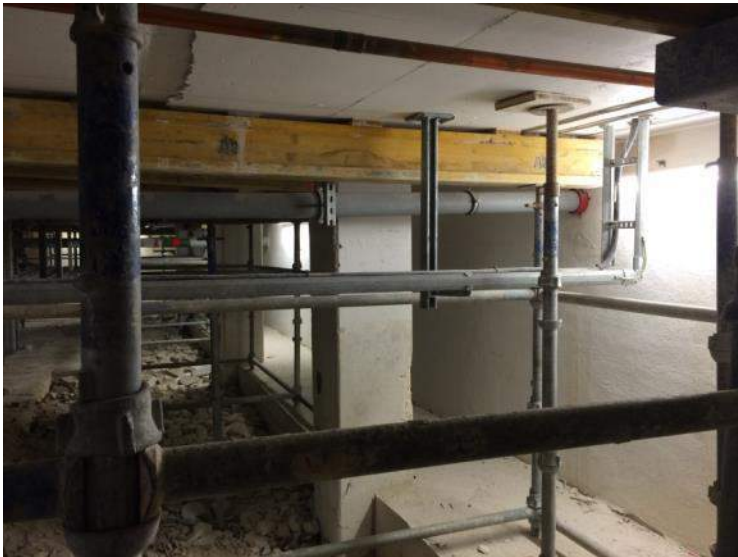
Figure 3: Propping to underside of Level 9 building D1.3

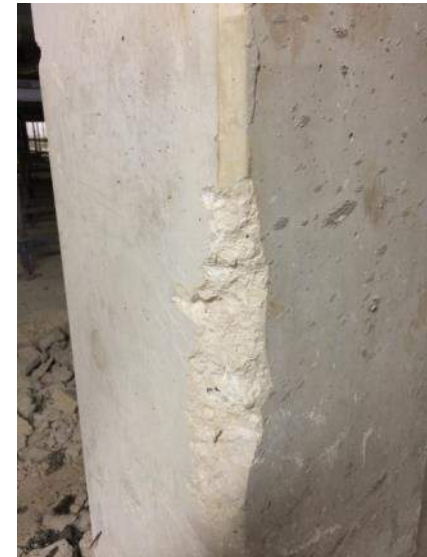
Figure 4: 'White' concrete column (D1.3)
