FMS
Mater Dei Hospital | Malta
Volume 2: MAU building

Issue | 20 May 2015

MAU building executive summary

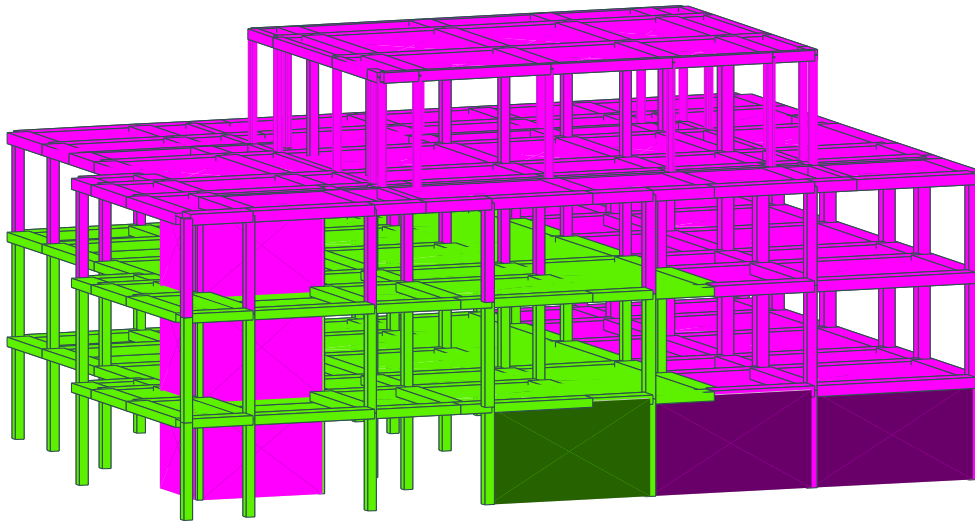
Figure 2 Block D1.1 construction sequence. Green: commenced in 1996. Pink: completed by 2007.

In 1996, construction of D1.1 levels 8, 9 and 10 commenced over part of the footprint, between gridlines 01/D1.1 and E/D1.1 (shown green in Figure 2). The remainder of D1.1 was built between 2002 and 2007.

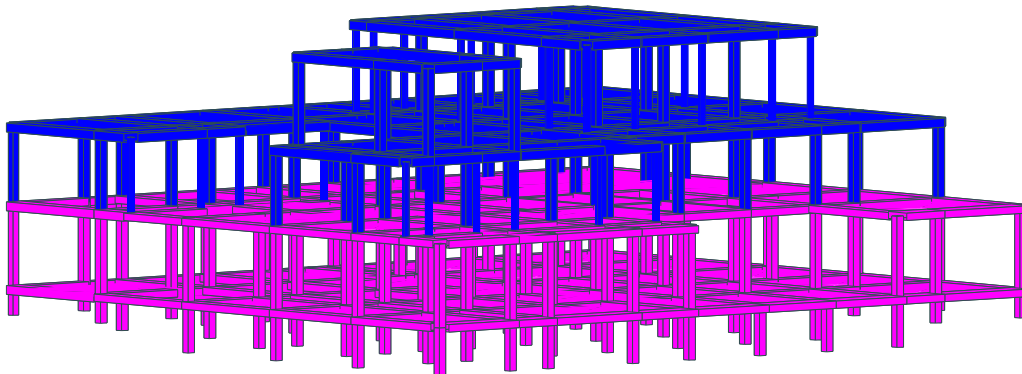
Figure 3 Block D1.3 assumed construction sequence. Pink: commenced in 1996. Blue: completed by 2007. Lift and stair cores not shown.

D1.3 Level 8, 9 and 10 were built in one continuous operation in 1996 (shown pink in Figure 3). By 2007, Level 11 (including two plant rooms), separate stair and lift cores as well as some minor structural amendments were complete.

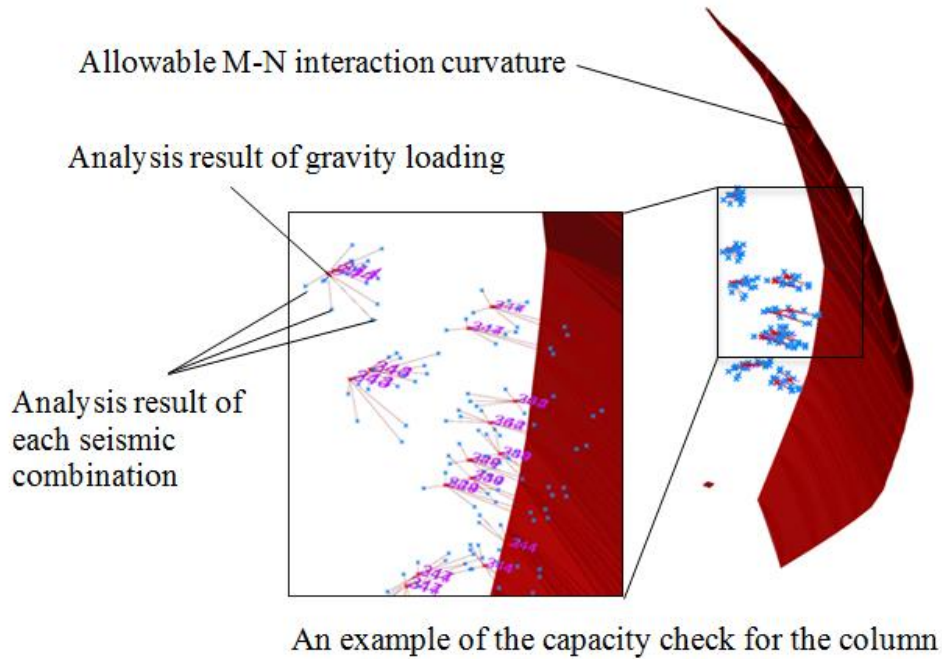
Figure 8 Example M/N plot for strength capacity

initially determined whether the columns were working above their capacity. For each column the seismic loads were then plotted against the gravity loading. This helped to identify which columns fell outside the M/N curve, under both gravity and seismic conditions. Figure 8 shows an example of the curve, all the columns of this particular type fall within the M/N curve and therefore within the design capacity.

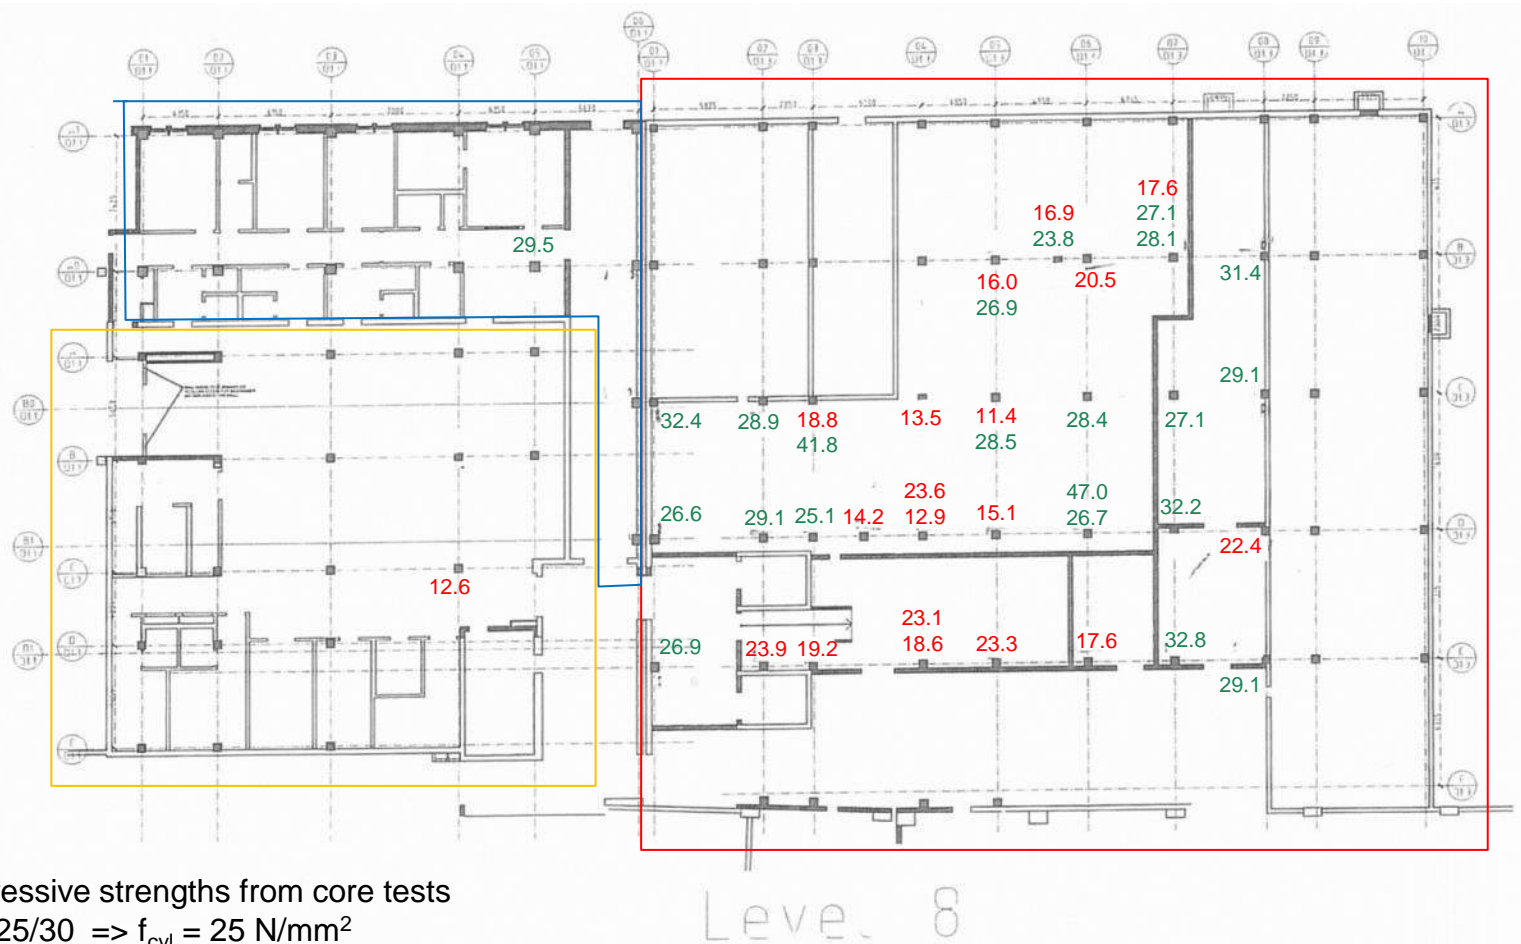
A&E Level 8

Typical columns 450mm x 450mm

Compressive strengths from core tests

$$f_{ck} = C25/30 \Rightarrow f_{cyl} = 25 \text{ N/mm}^2$$

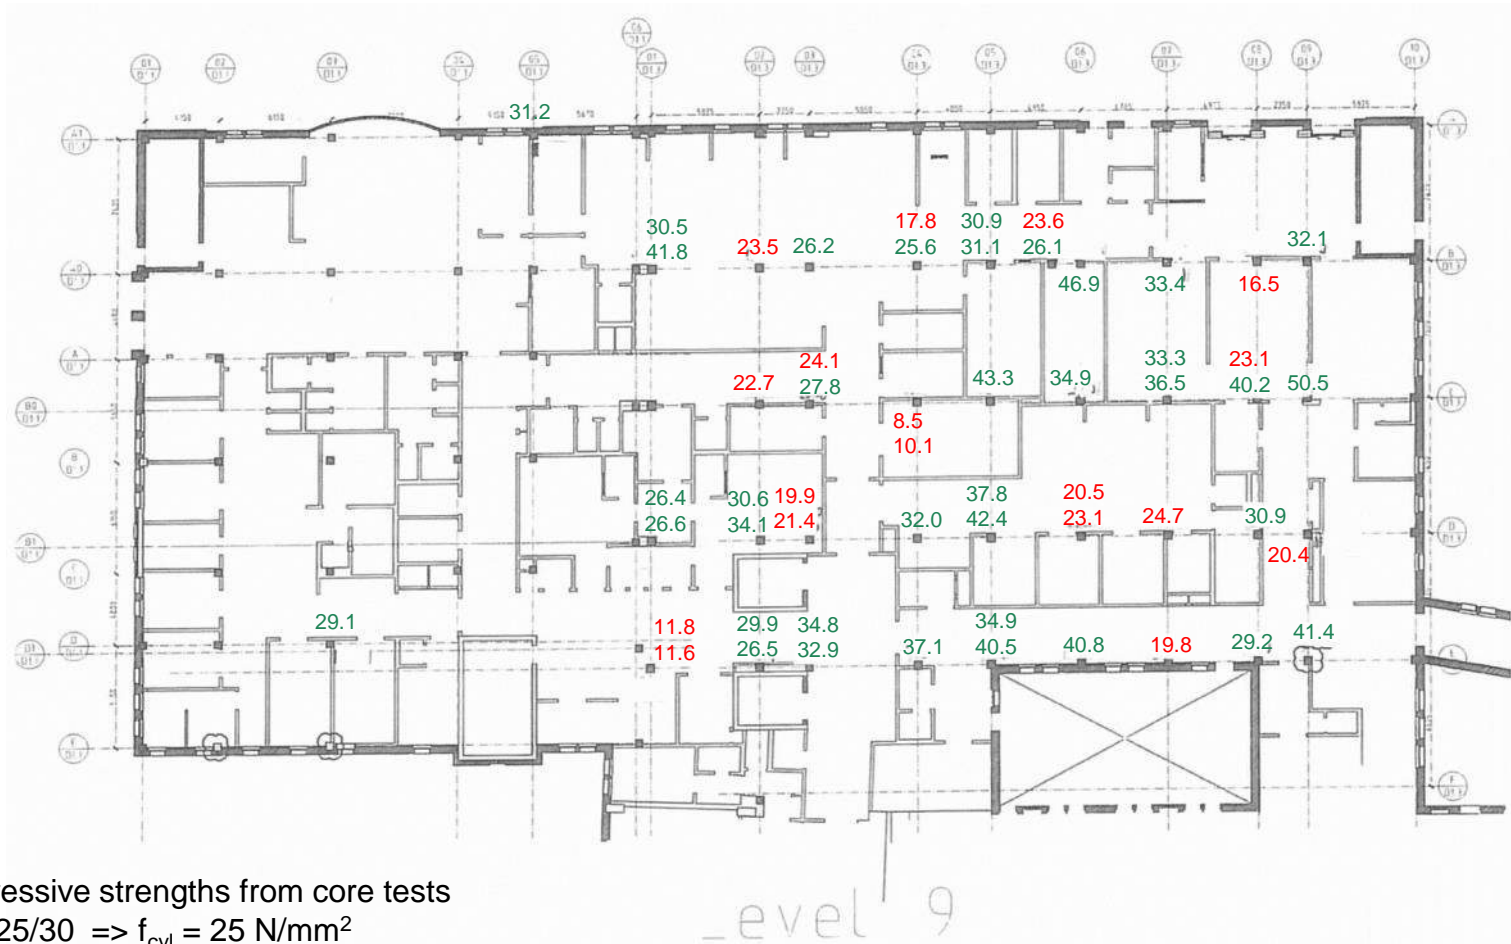
A&E Level 9

Typical columns 450mm x 450mm

Compressive strengths from core tests

$f_{ck} = C25/30 \Rightarrow f_{cyl} = 25 \text{ N/mm}^2$

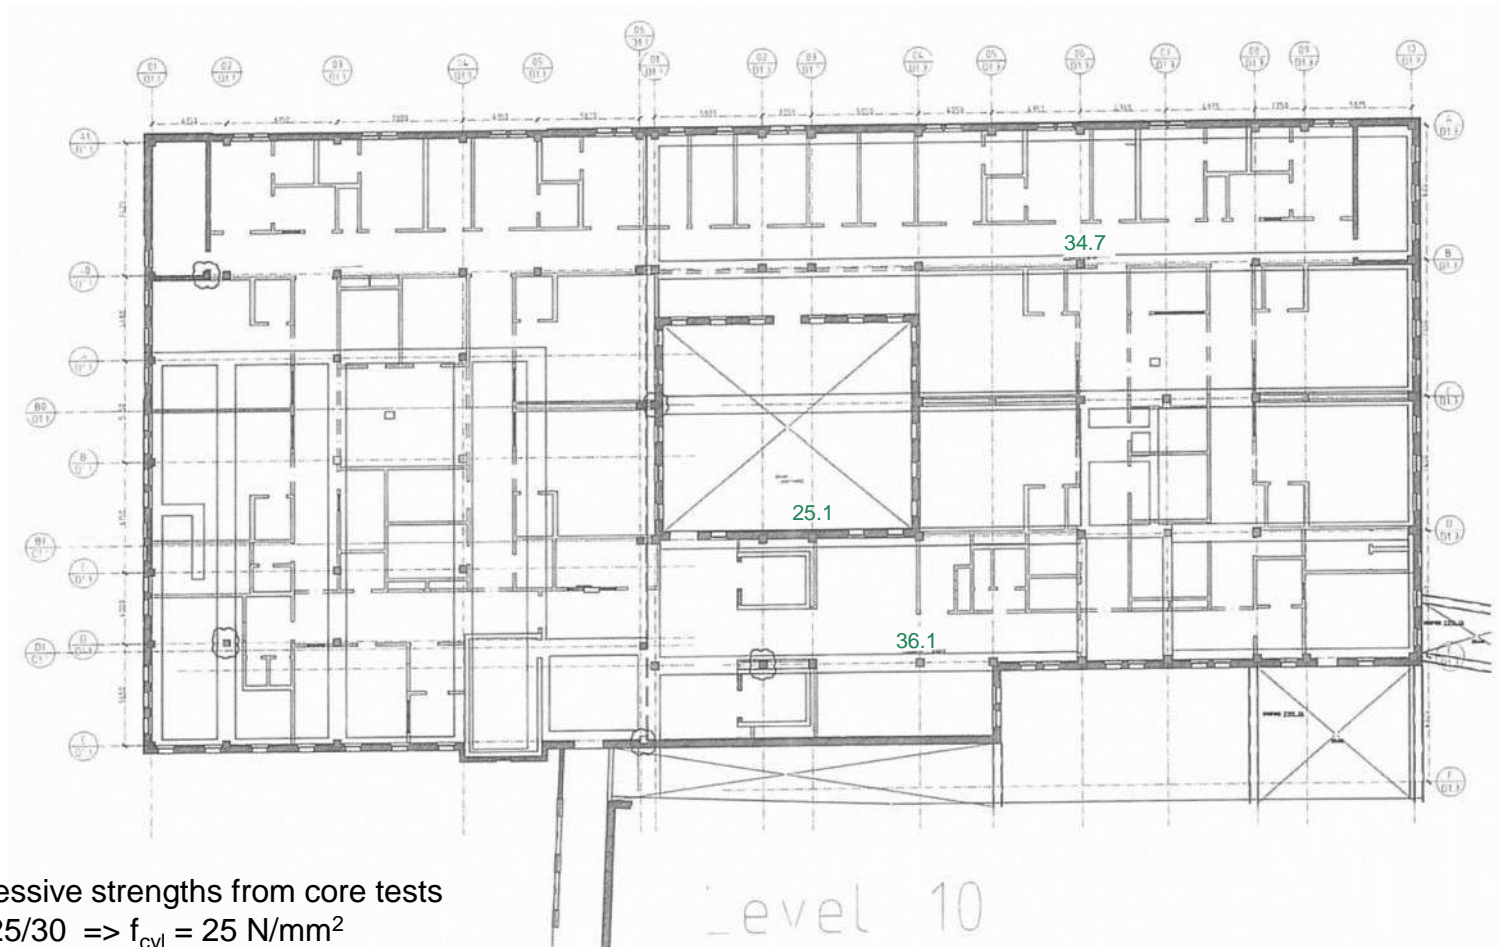
A&E Level 10

Typical columns 450mm x 450mm

Compressive strengths from core tests

$$f_{ck} = C25/30 \Rightarrow f_{cyl} = 25 \text{ N/mm}^2$$

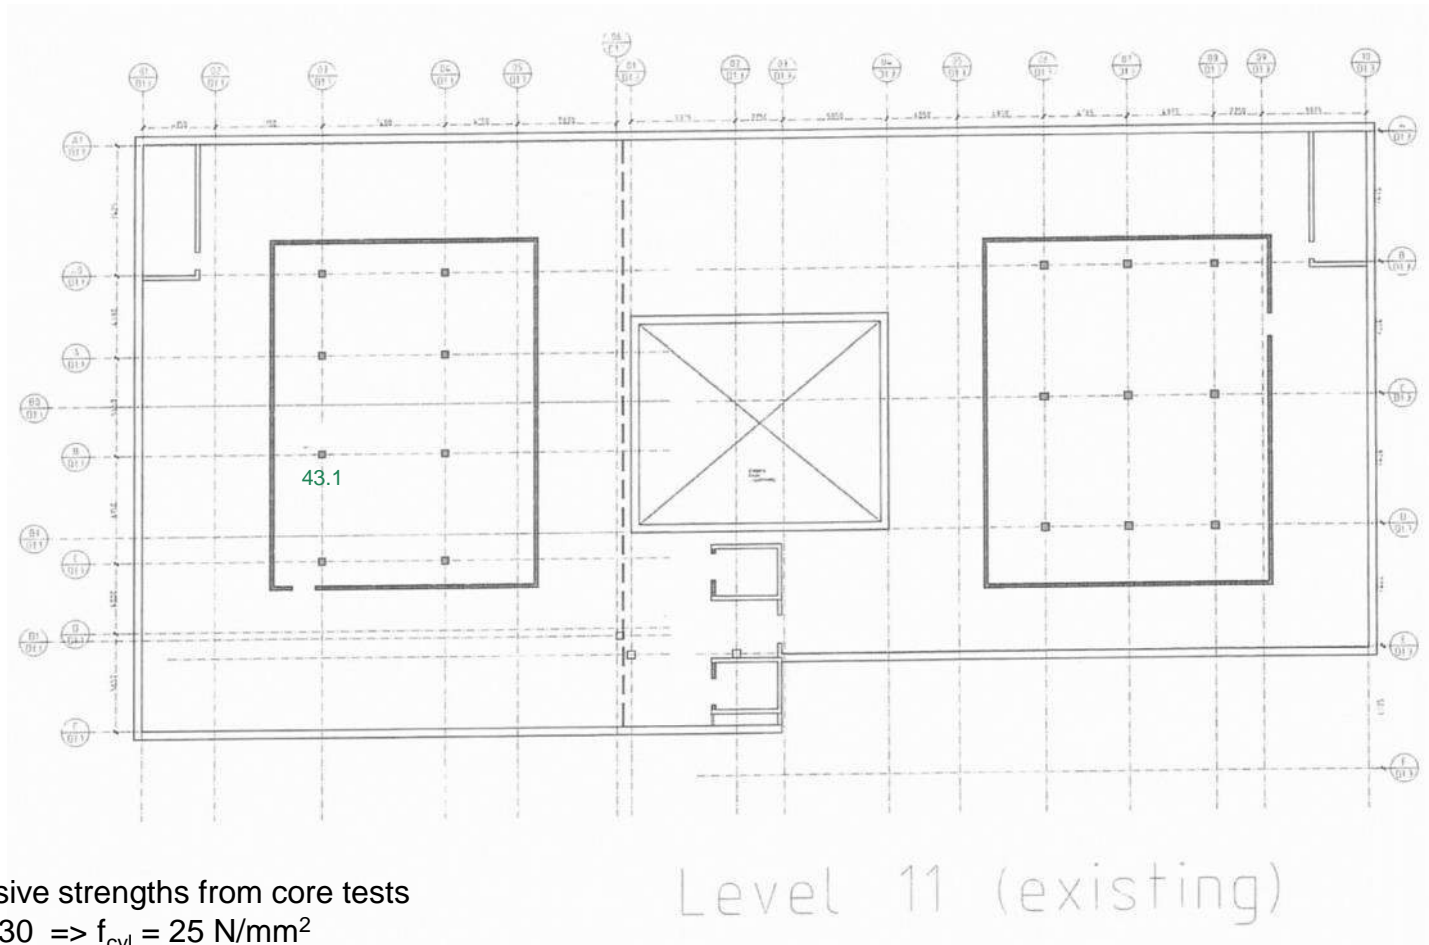
A&E Level 11

Typical columns 450mm x 450mm

Compressive strengths from core tests

$$f_{ck} = C25/30 \Rightarrow f_{cyl} = 25 \text{ N/mm}^2$$

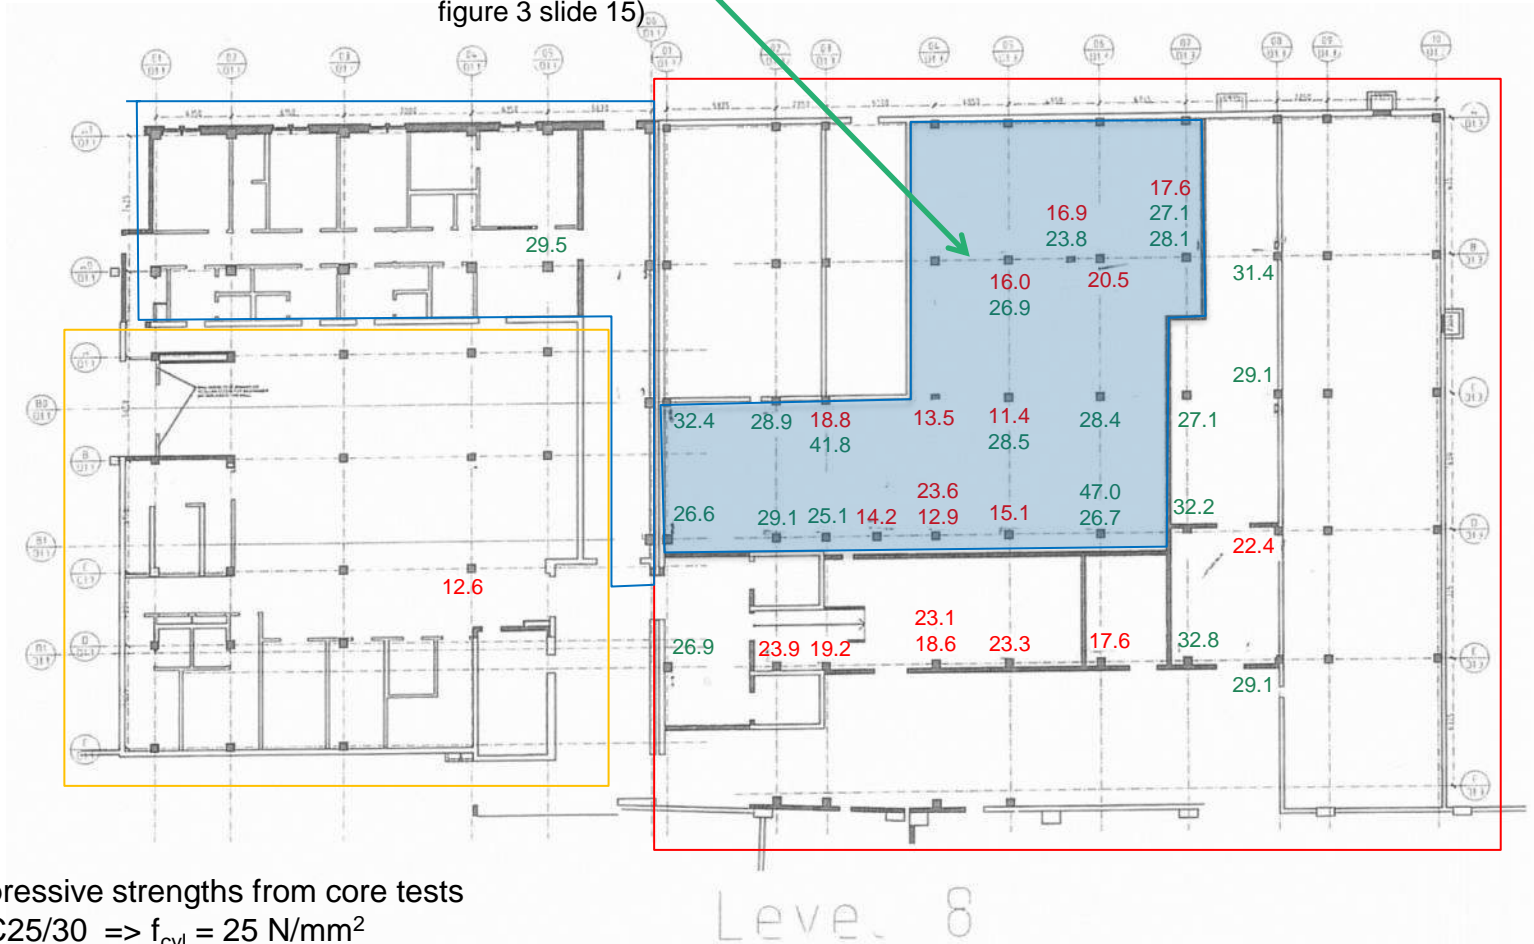
Typical columns 450mm x 450mm

Shading denotes area of propping (refer to figure 3 slide 15)

Compressive strengths from core tests

$$f_{ck} = C25/30 \Rightarrow f_{cyl} = 25 \text{ N/mm}^2$$
